**GEOTECHNICAL EVALUATION**  
Centralia Alpha Road Alignment Project  
Centralia Alpha Road between  
Senn Road and Oppelt Road  
Lewis County, Washington

Prepared for: Lewis County Public Works

Project No. 180370 • September 14, 2018

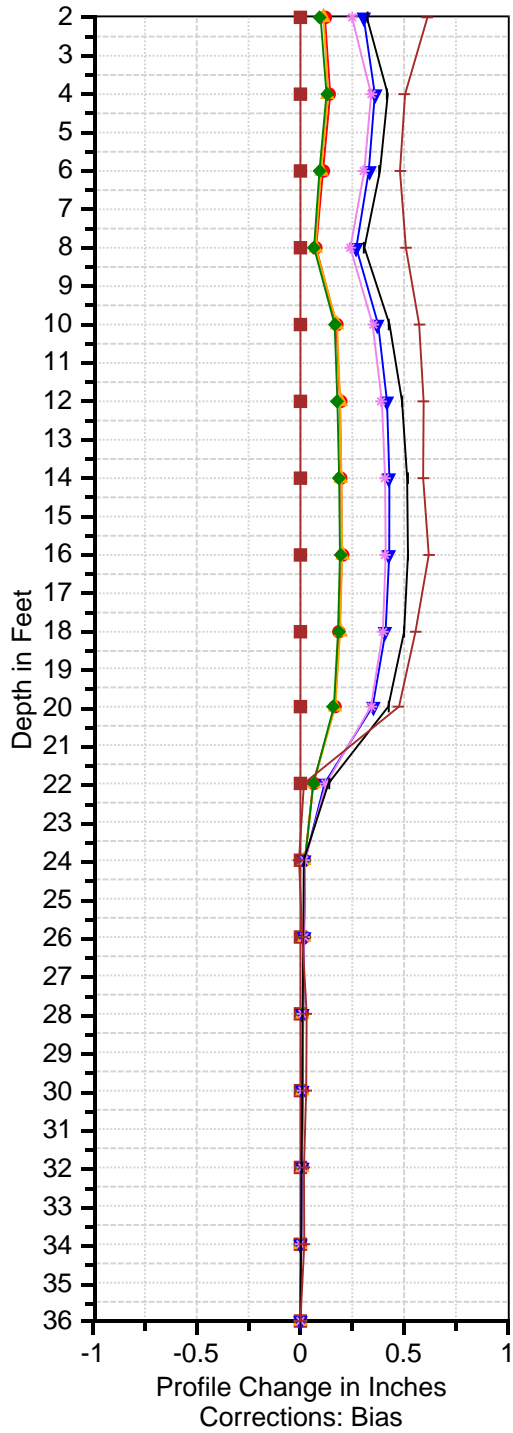
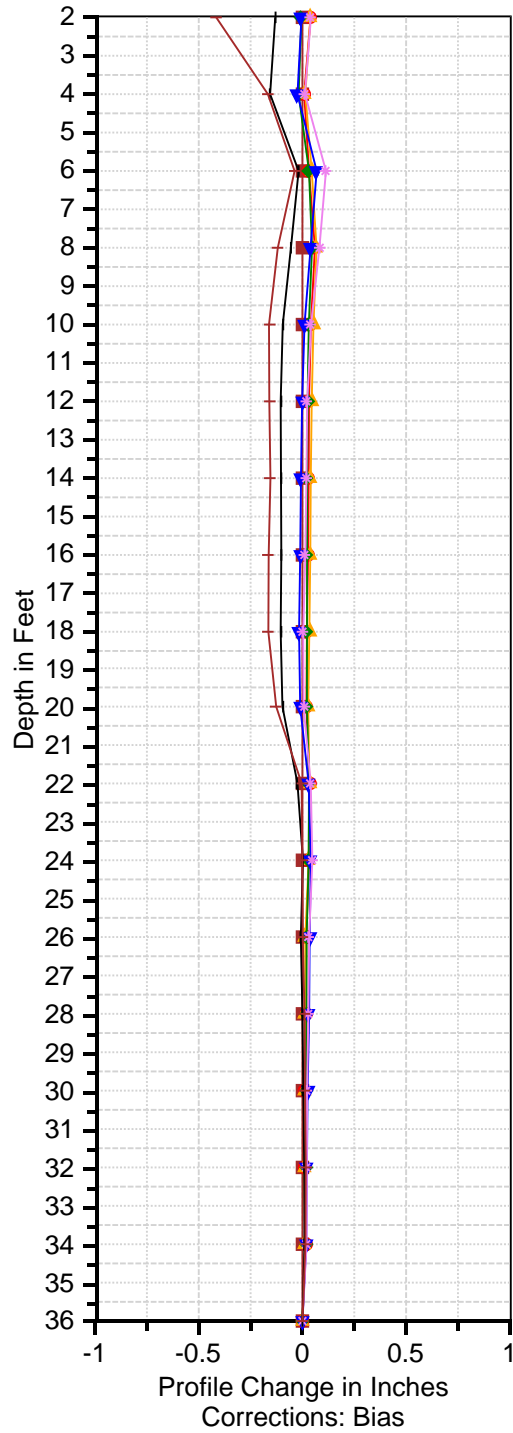
**Inclinometer B-1:** Inclinometer B-1 has recorded yearly episodes of measurable deflection since October 2015 (Appendix B, B-1 Profile Change) with a zone of

deflection between 16 and 24 feet bgs. A discrete date and rate of deflection during ground movement cannot be ascertained from the periodic readings. The vector deflection between June 2017 and August 2018 was approximately 0.12 inches, and the total vector casing deflection from October 2014 to August 2018 has been 0.64 inches.

- Inclinator casing deflections toward the river channel were recorded in boring B-1 between October 2014 and August 2018 and in B-9 between June 2017 and August 2018, indicating this area is marginally stable to unstable.

- The zone of deflection in B-1 and B-9 generally align with the contact between the softer Logan Hill Formation and the underlying, more competent Wilkes Formation at approximately 20 feet bgs.

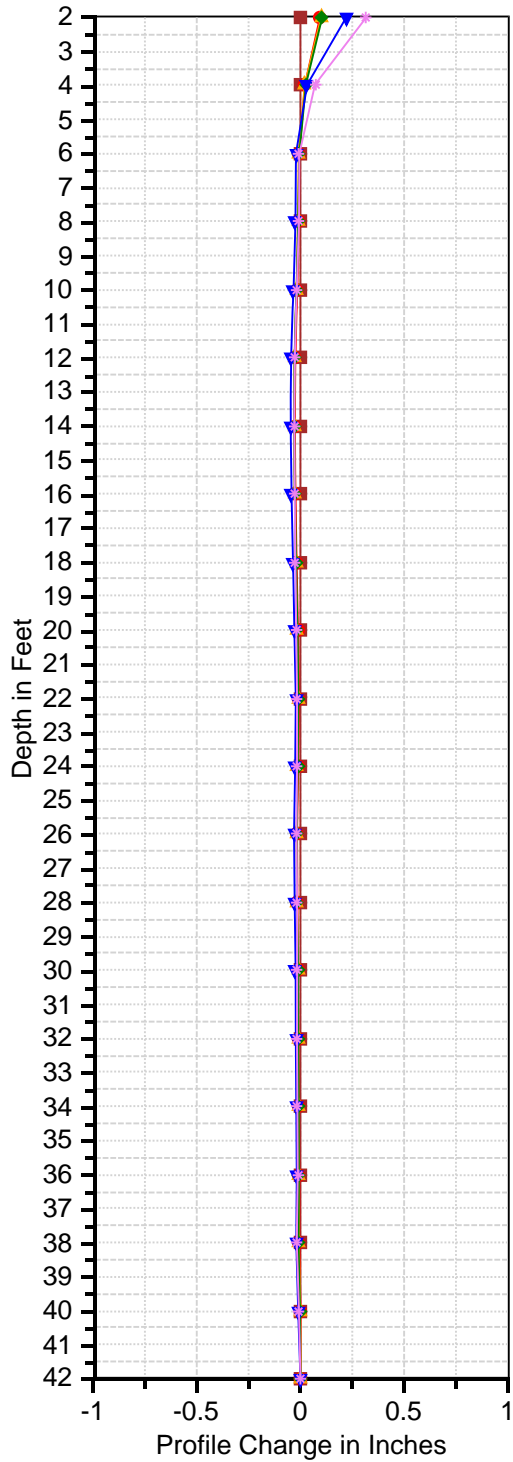
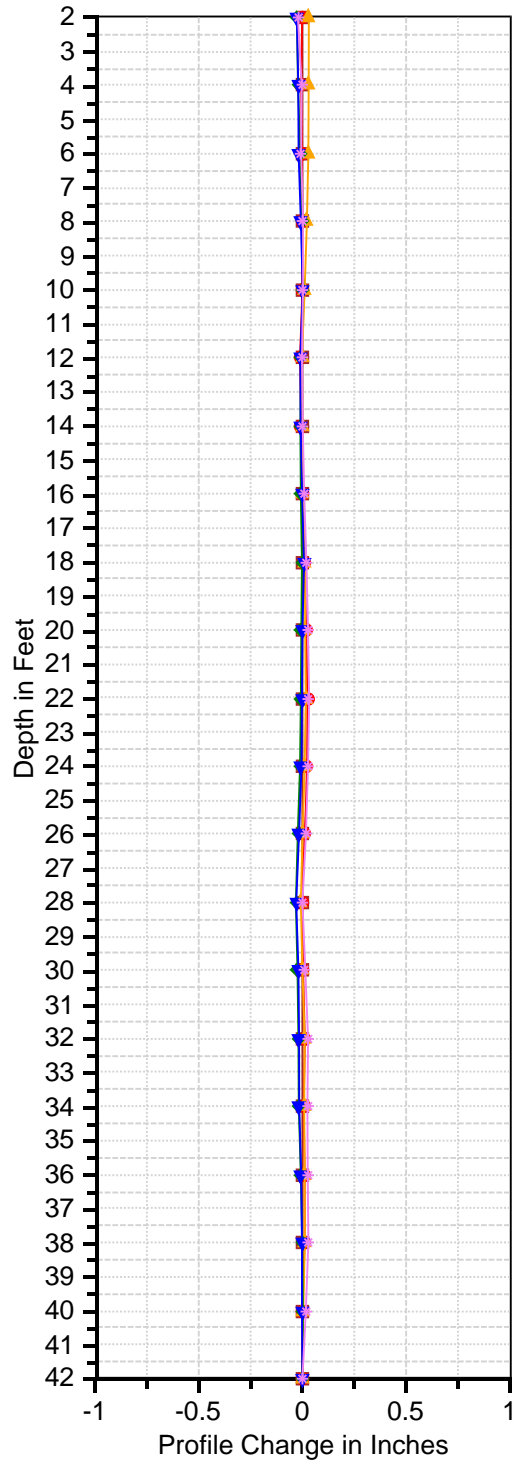
**Inclinometer B-3:** Inclinometer B-3 recorded deflections of less than the instrument accuracy of 0.002 inches from initial installation in October 2015 through June 2017.

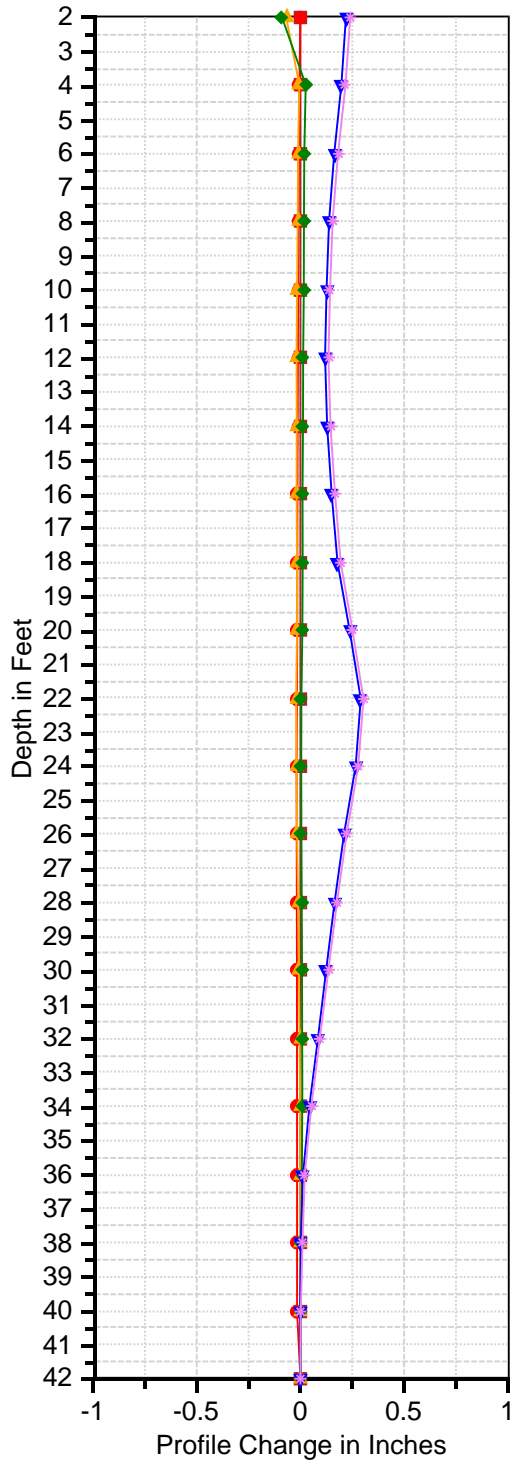
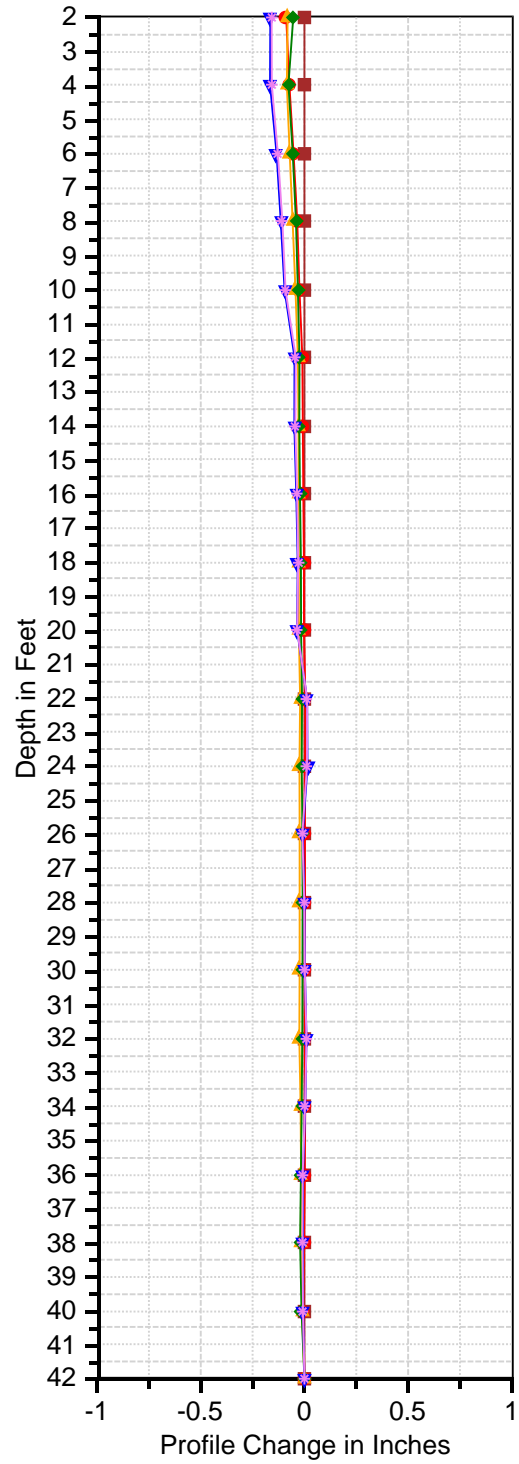
**Inclinometer B-9:** Inclinometer B-9, located approximately 60 feet south of B-1 and off the road, recorded no deflection between its initial installation in March 2015 and June 2017. Recent measurements indicate likely movement has occurred between June 2017 and our August 2018 readings. Some of the perceived deflection may be due to a rotational error caused by using two different inclinometer instruments. However, the shape of the graph does indicate measurable deflection.

The plot of the data is more curved and less discrete than in B-1, with an estimated zone of deflection between 22 and 32 feet bgs. A discrete date and rate of deflection during ground movement cannot be ascertained from the periodic readings. The vector deflection between June 2017 and August 2018 was approximately 0.24 inches, and the total vector casing deflection from October 2014 to August 2018 has been 0.25 inches.

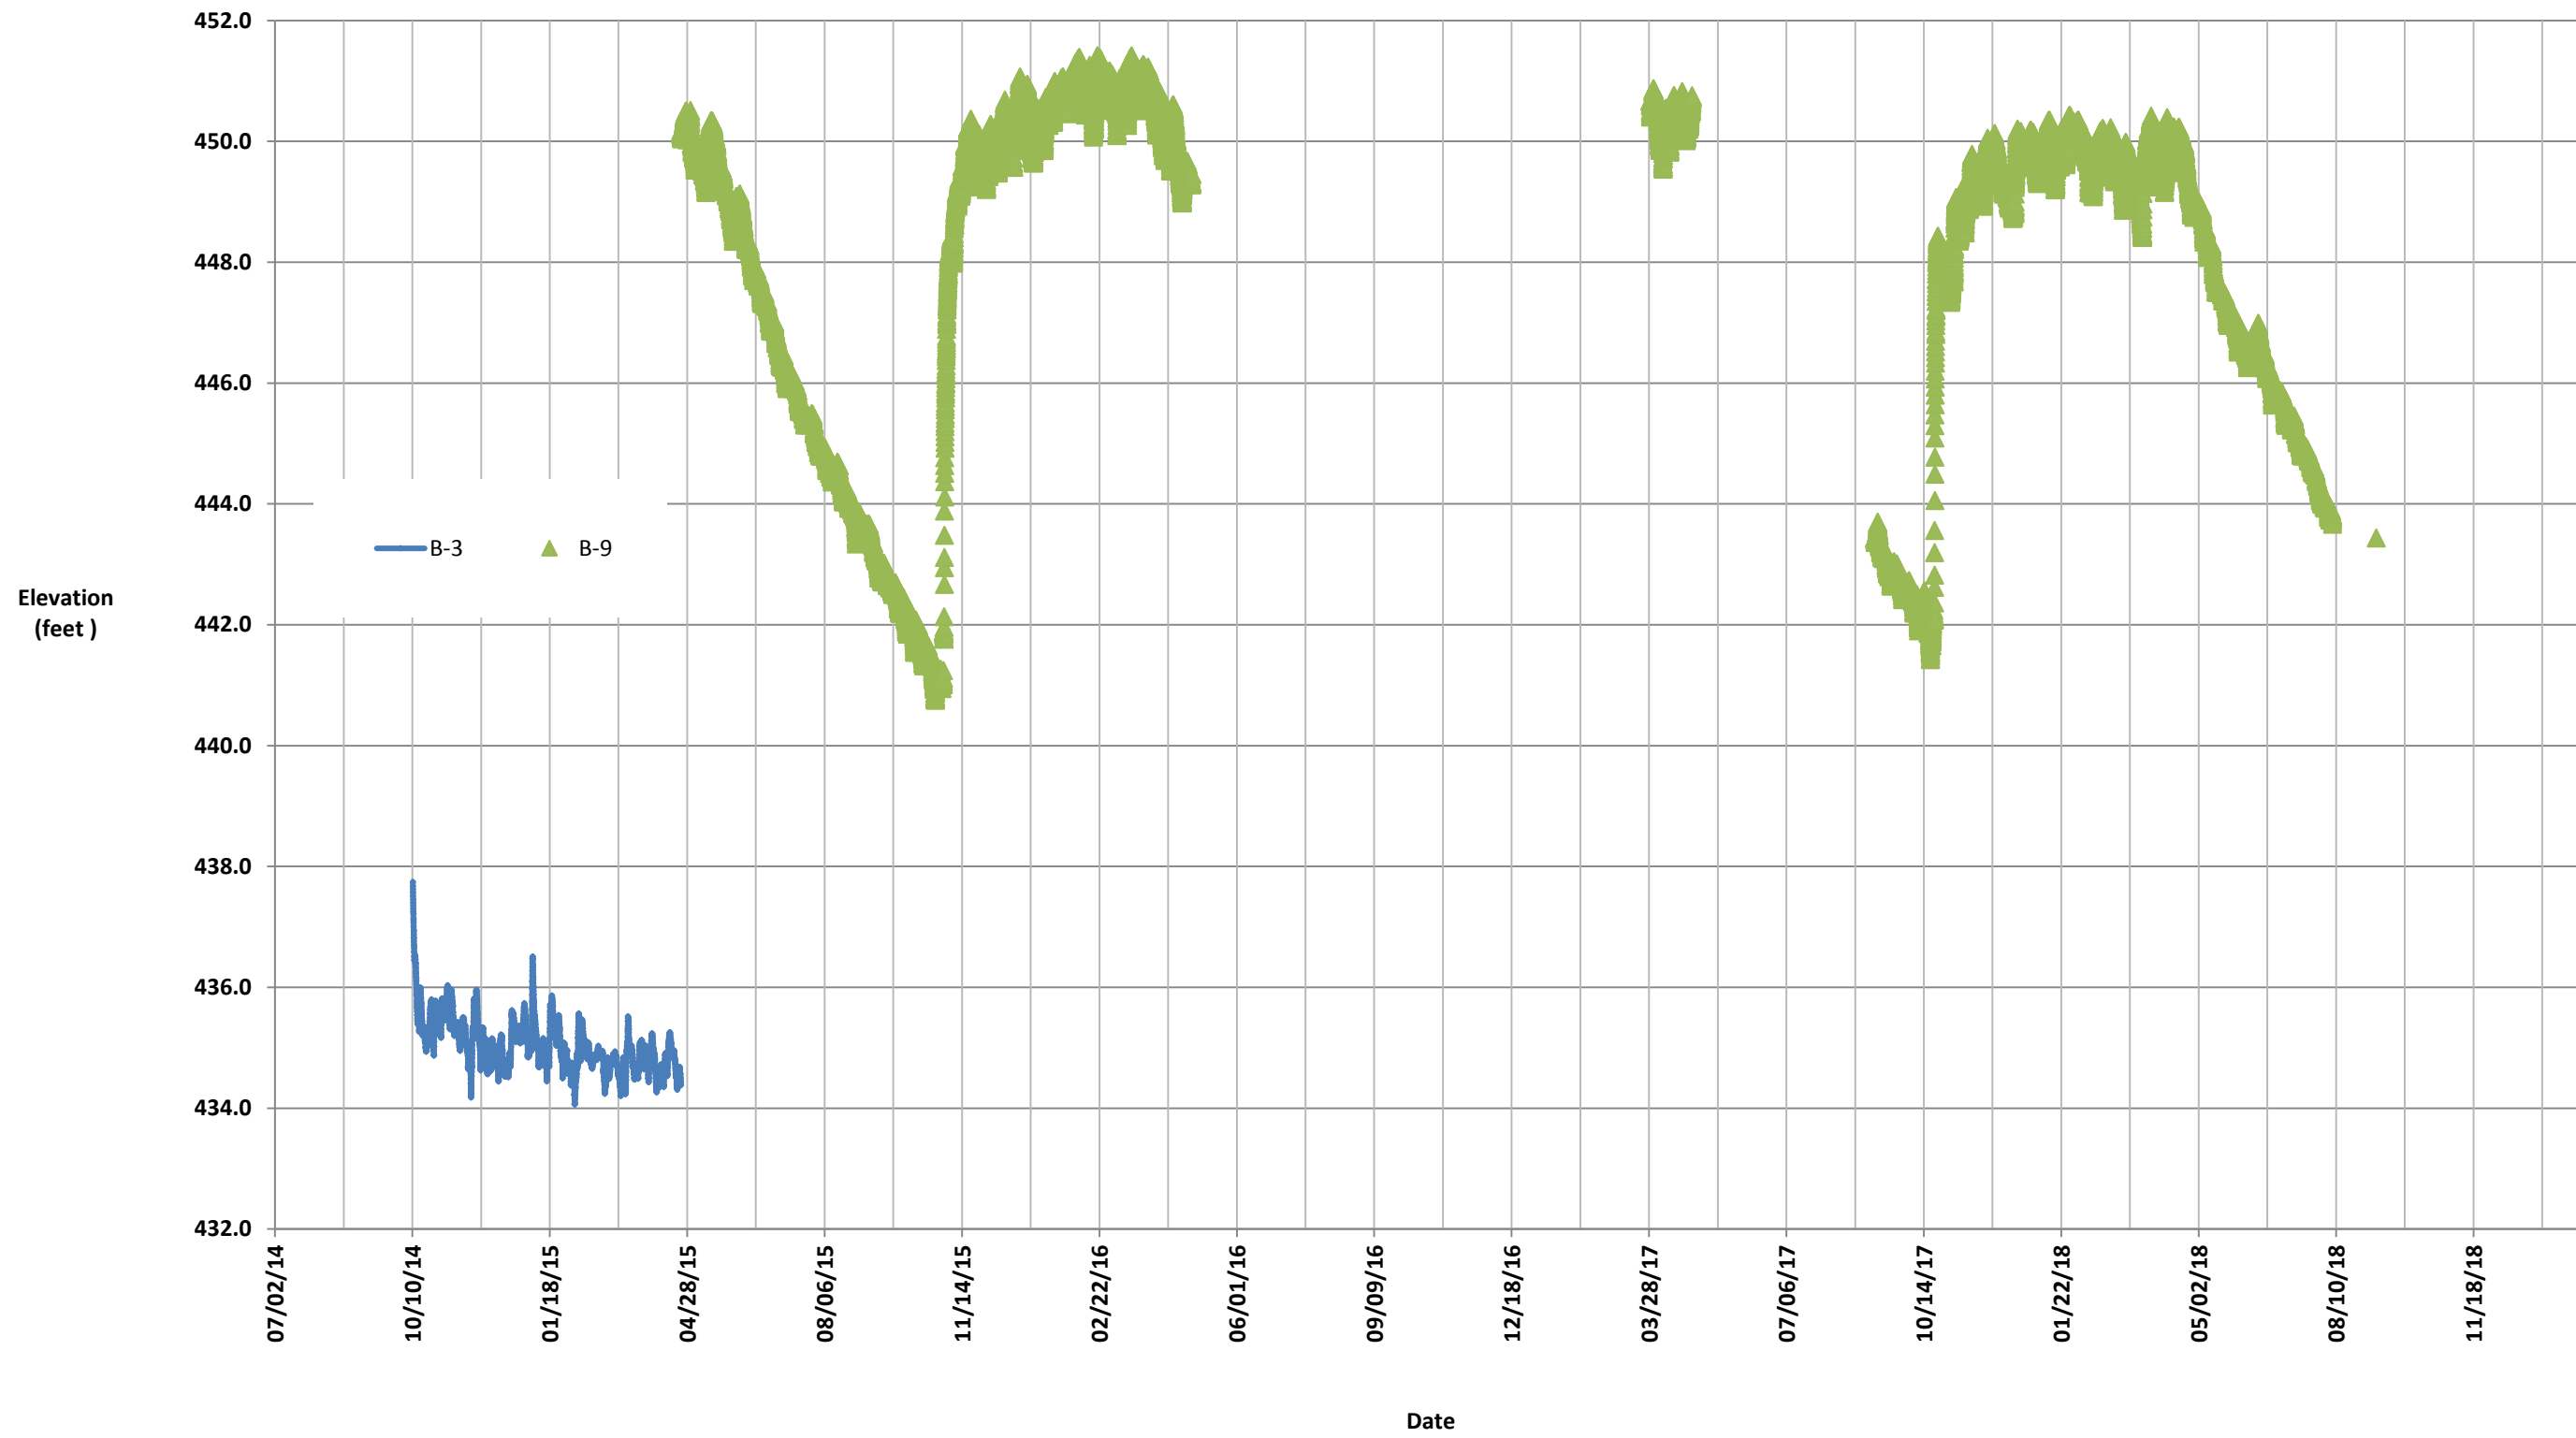
### Borings B-3 and B-9 Piezometer Readings

The VW piezometer installed in boring B-3 recorded groundwater depths between 19 and 23 feet bgs (Elevation [EL] 438 feet and EL 434 feet<sup>1</sup>) from October 2014 to April 2015. No additional readings were acquired after April 2015, and the VW piezometer is no longer accessible.

The depth to groundwater in boring B-9 was initially measured on March 24, 2015, at approximately 1.5 feet bgs and on April 23, 2015, at approximately 5 feet bgs. During our Site visit on August 7, 2018, the VW piezometer data was downloaded. In addition, PBS provided readings acquired between April 2015 and May 2016. A gap in the data occurred between June 2016 and August 2017, though readings were recorded in April 2017. From April 2015 to August 2018, groundwater levels have fluctuated between approximately 4.5 and 14.5 feet bgs (EL 453.5 feet and EL 440 feet). These data show a seasonal trend, with groundwater levels deeper in the summer and fall and shallower in the winter and spring (Appendix B).

- Although the inclinometer casings are measured periodically, and a discrete timeframe of movement cannot be determined, movement is likely connected to higher groundwater levels during the winter and spring, which can fluctuate by up to 10 feet with the seasons.
