NHC Ref. No. 2006082

Lewis County Public Works

Re: Crumb Road Culvert Replacement
Hydraulic Memo

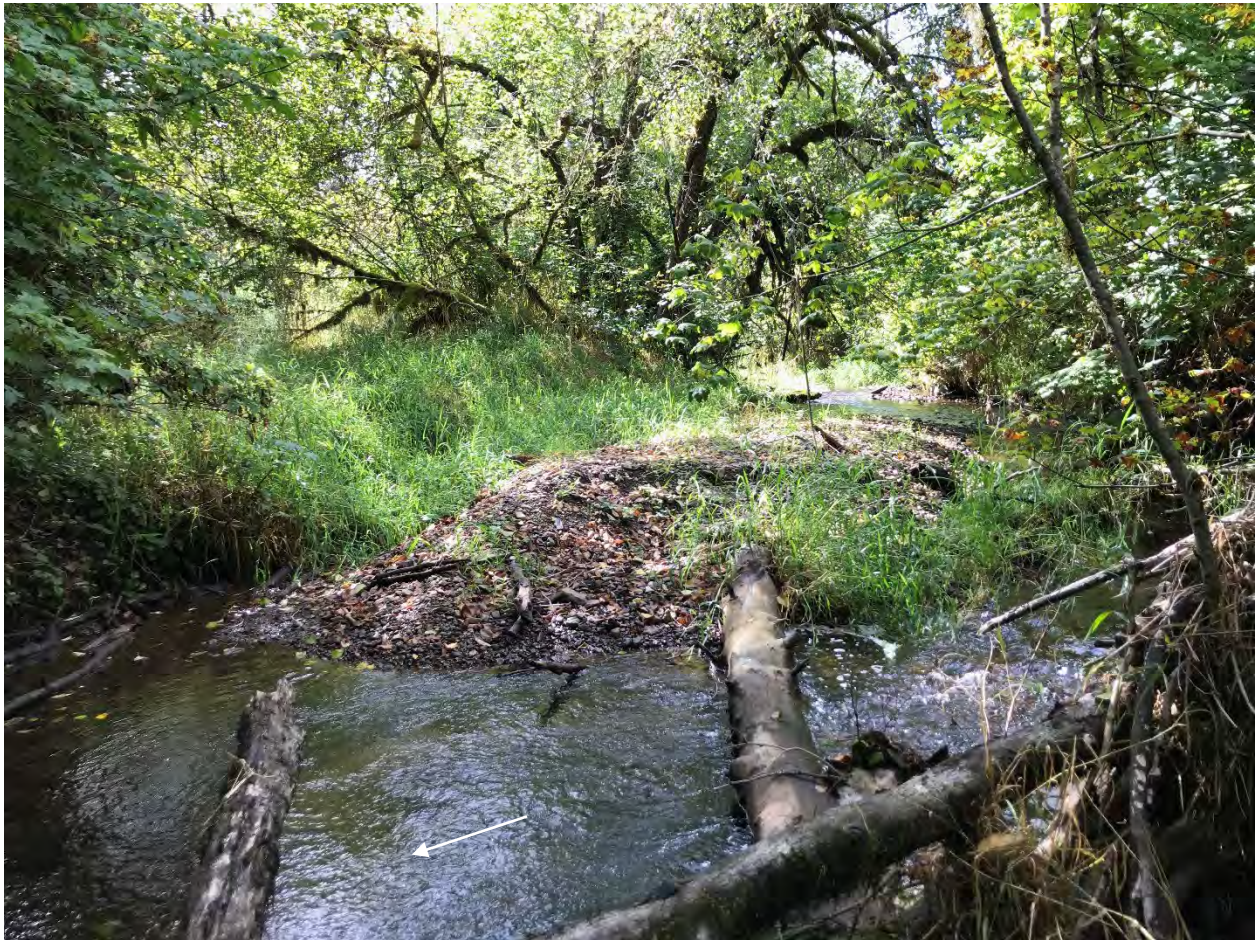
Figure 1 Wood-forced pools and lateral gravel bars upstream of Crumb Road

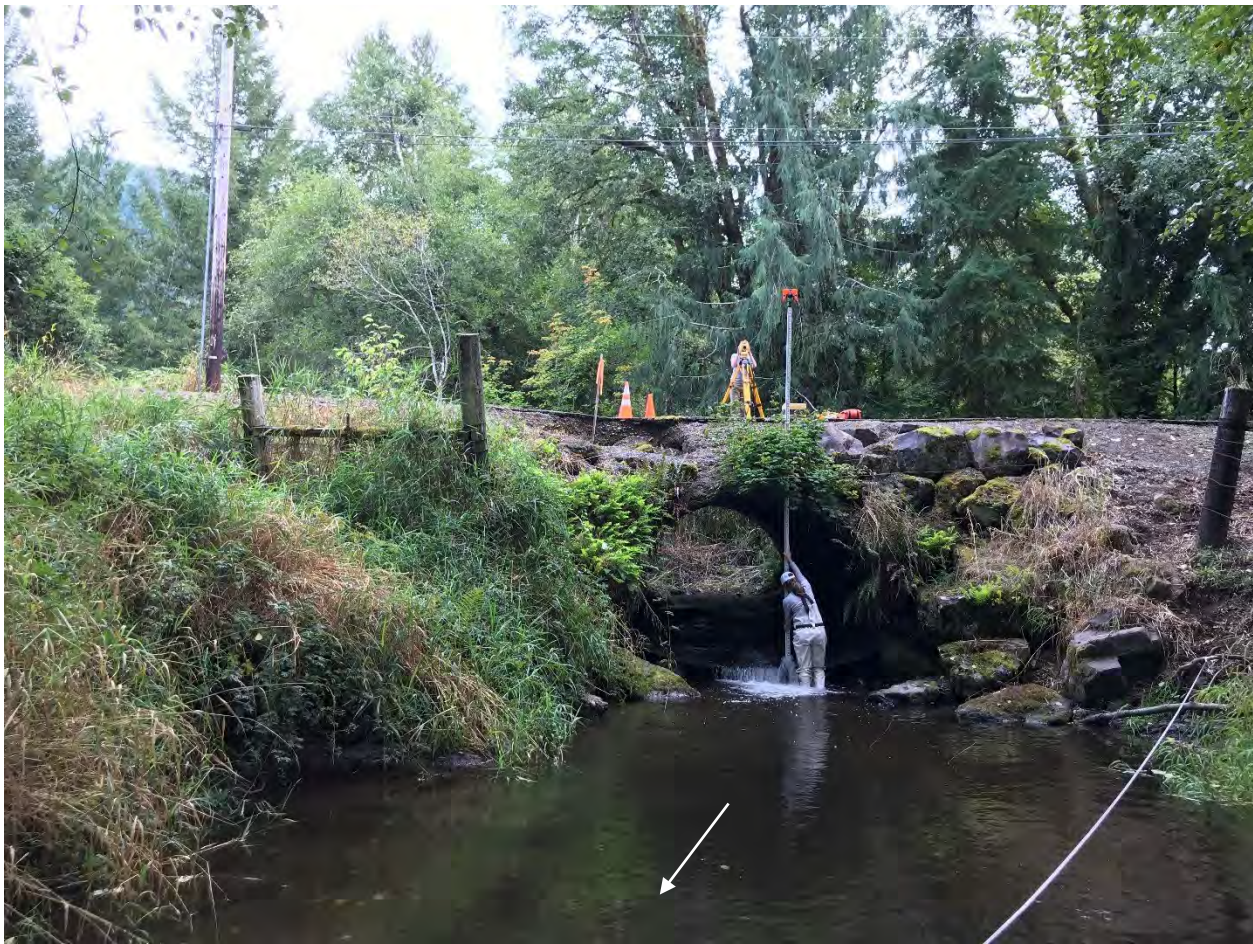
wood and pieces of mudstone. Large angular rock from the roadway fill was in the channel in the immediate vicinity of the culvert inlet and outlet. The water surface drop at the outlet was 7 inches during the time of the survey (Figure 2). A large outfall pool has formed downstream in the widened reach before the stream transitions to confined channel conditions 50 feet downstream of the outlet. Bankfull width decreases to an average of nine feet as the channel bends sharply into the confined reach, with bank heights between four and five feet tall. The scour along the left bank has exposed mudstone bedrock and undercut mudstone banks.

Figure 2 Existing conditions at the Crumb Road culvert outlet

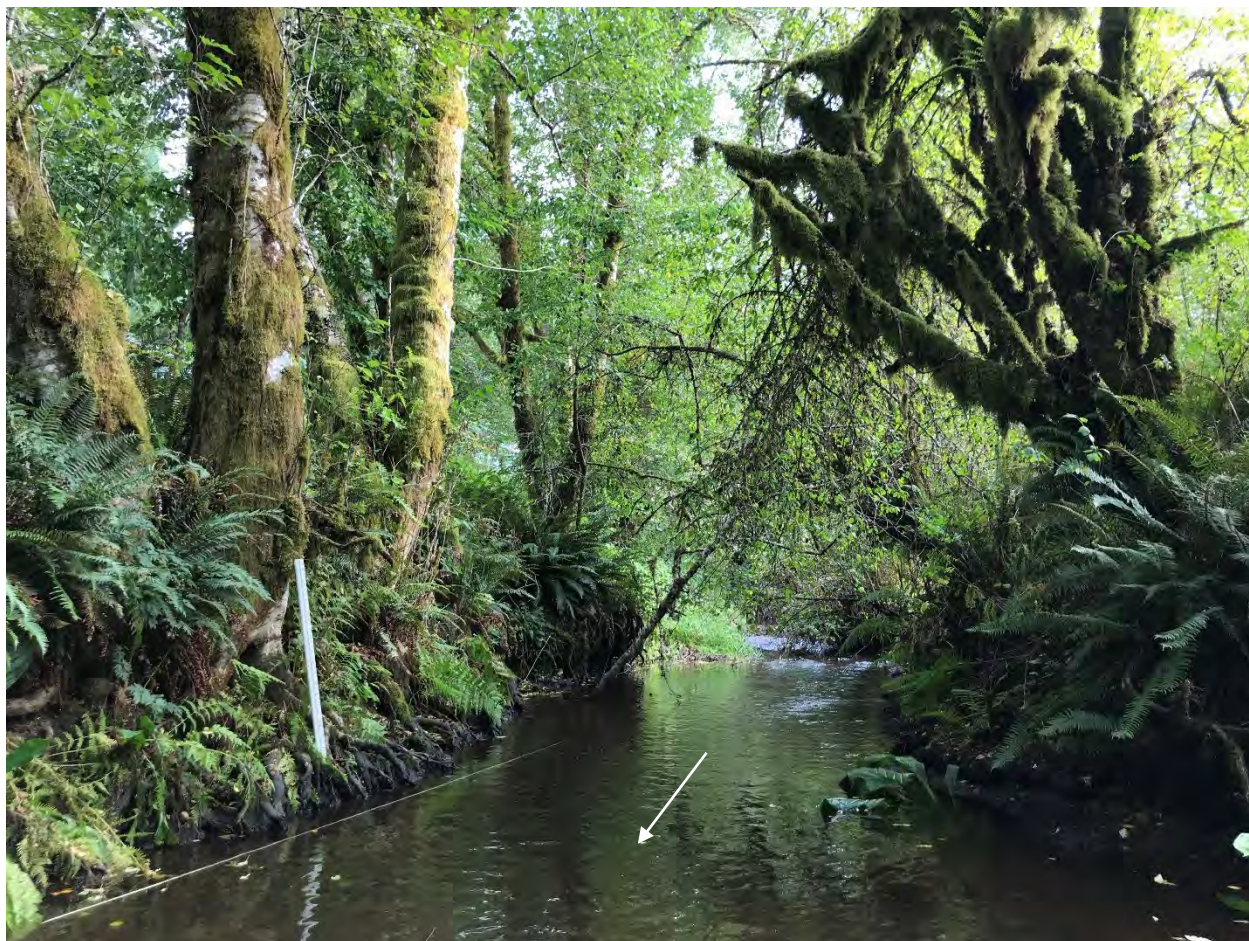
Figure 3 Mature trees reinforce vertical mudstone banks downstream in a long deep pool

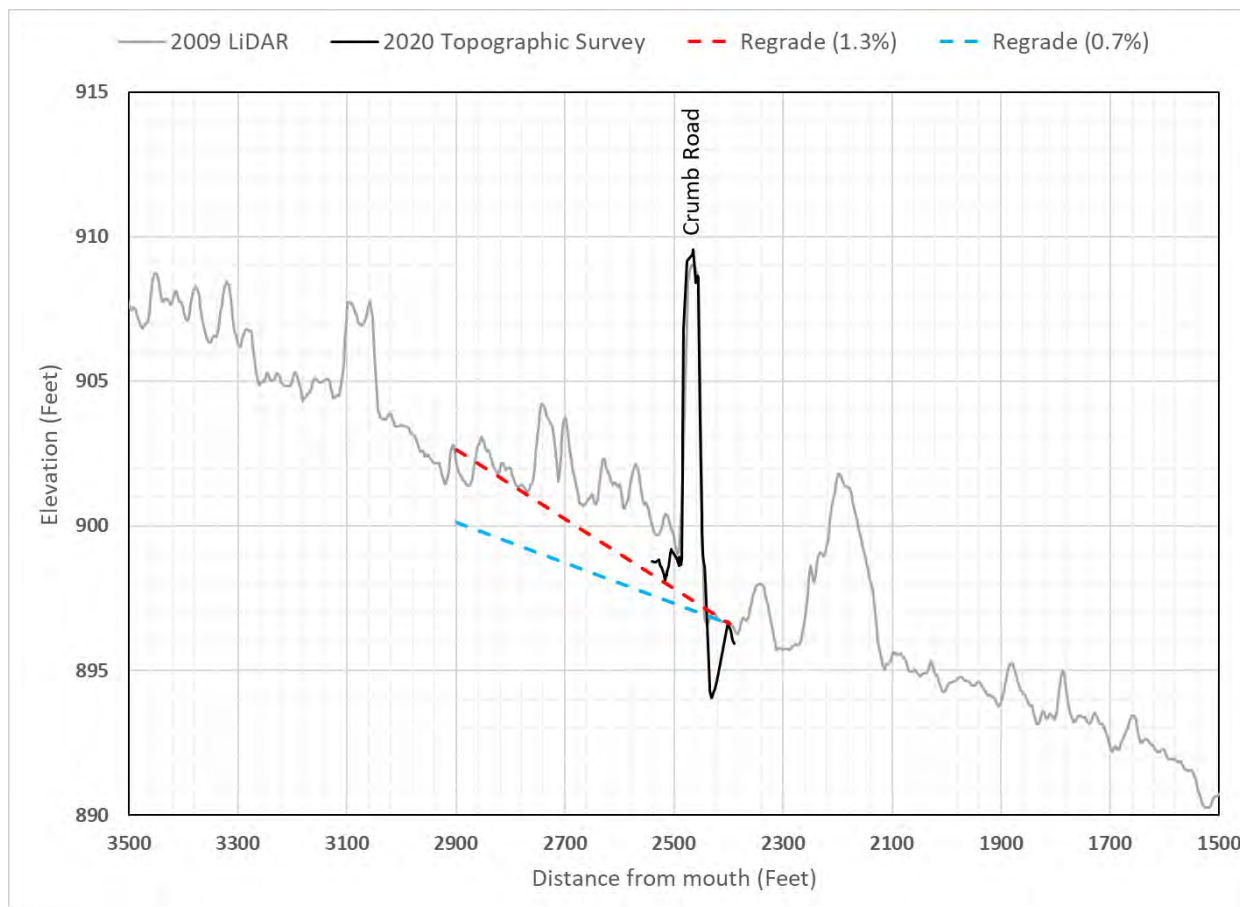
LiDAR profile, the upstream and downstream water surface slopes are approximately 0.8%, with locally steeper slopes along riffles (Figure 7). A two-foot-deep scour pool has formed immediately downstream of the over-steepened 4% grade culvert.

Figure 7 Longitudinal profile of Highland Creek

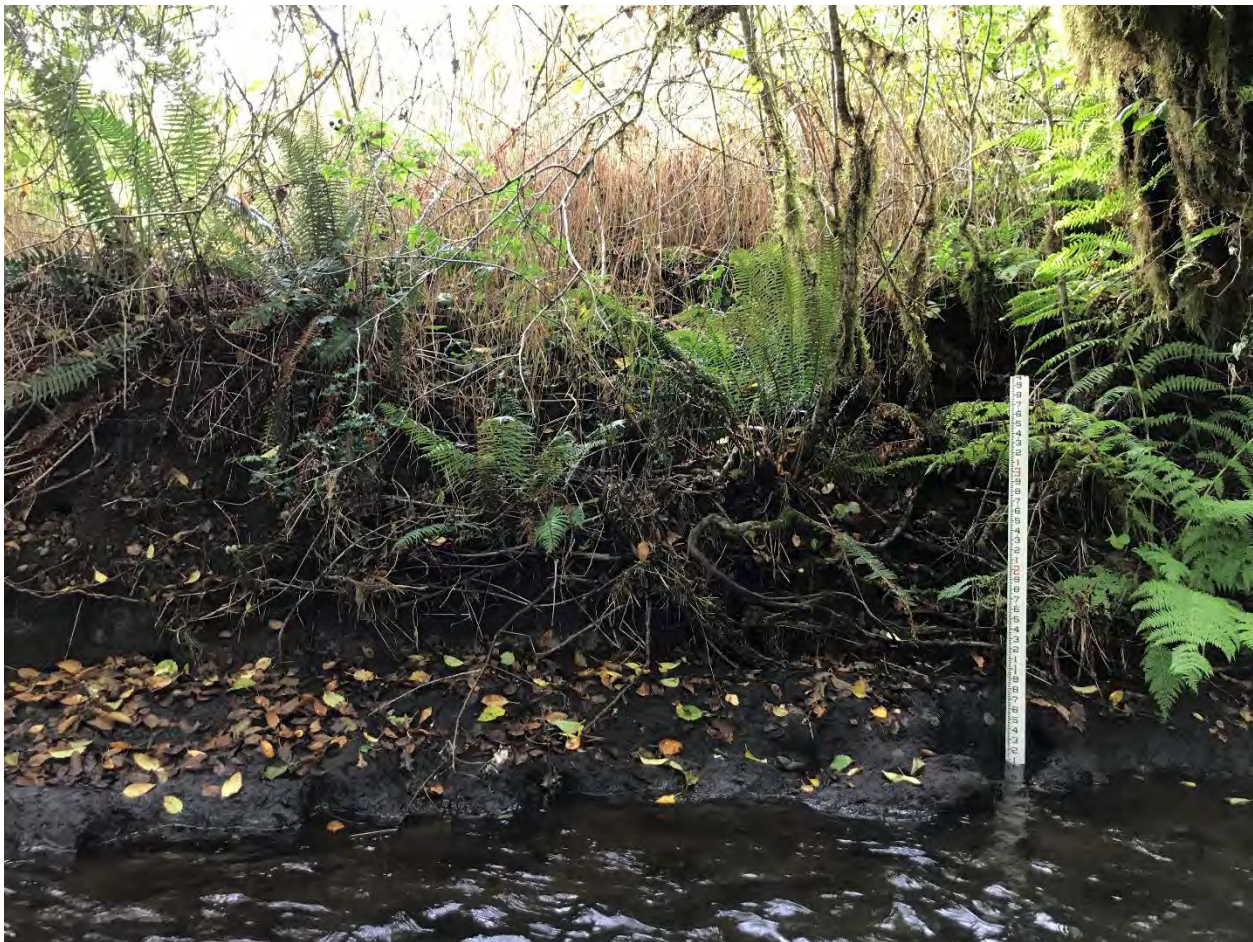
Highland Creek downstream of Crumb Road is entrenched 3.5 to 5 feet below the surrounding floodplain, where it is incising into the blocky mudstone (Figure 8). High bank strength downstream limits channel widening, and is a function of both erosion-resistant mudstone bedrock (the same

Figure 8 Down-cut banks downstream of Crumb Road expose mudstone and roots

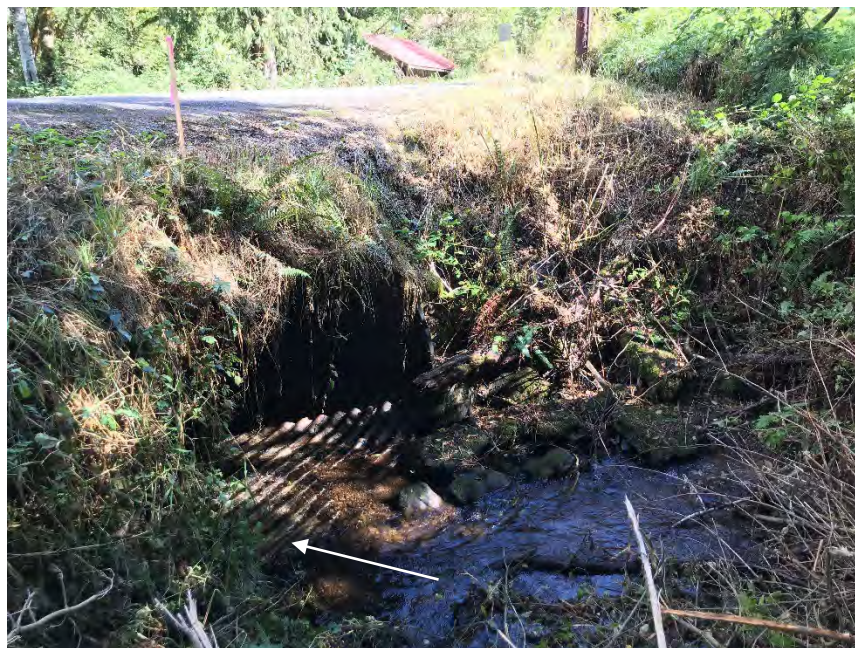
Figure 14: Conditions at the culvert inlet, including eroded roadway fill and a lack of alluvial cover on the culvert bottom (Station 25+00, white arrow indicates flow direction)

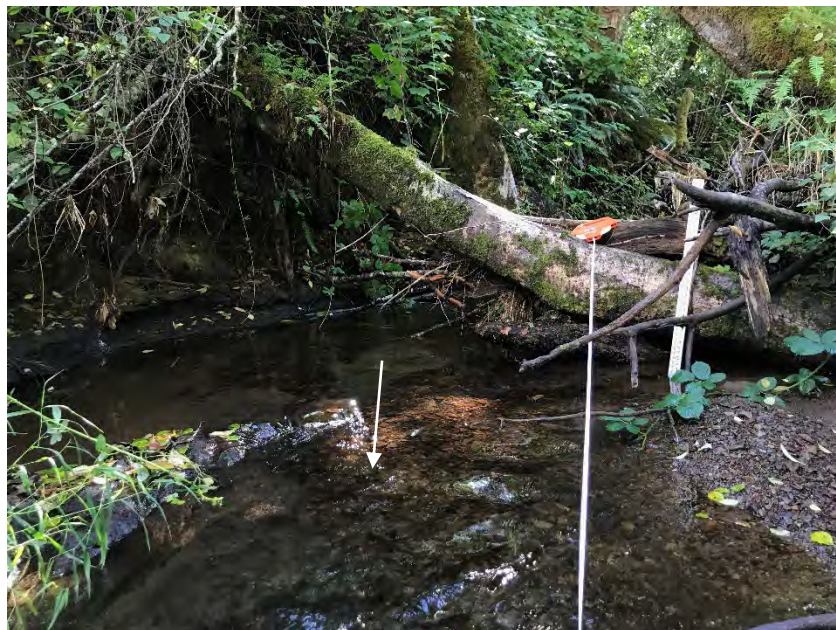
Figure 15: View of the channel bend upstream of the culvert inlet, with exposed mudstone bed, bank scour, and a debris jam forming on a large tree spanning much of the channel (Station 25+70, white arrow indicates flow direction)

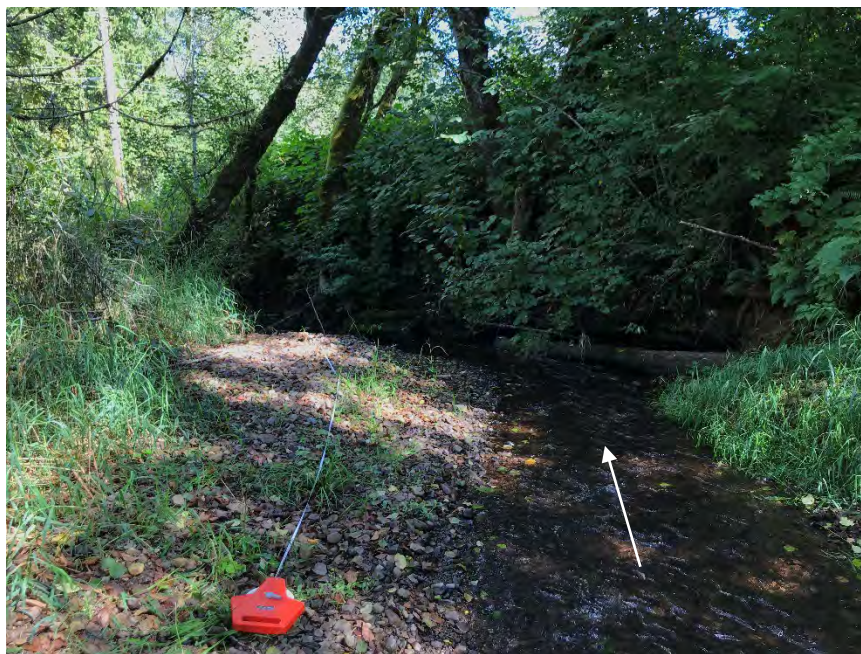
Figure 16: View of the channel bend from downstream, including the extensive gravel bar that has formed on the left bank (Station 26+10, white arrow indicates flow direction)

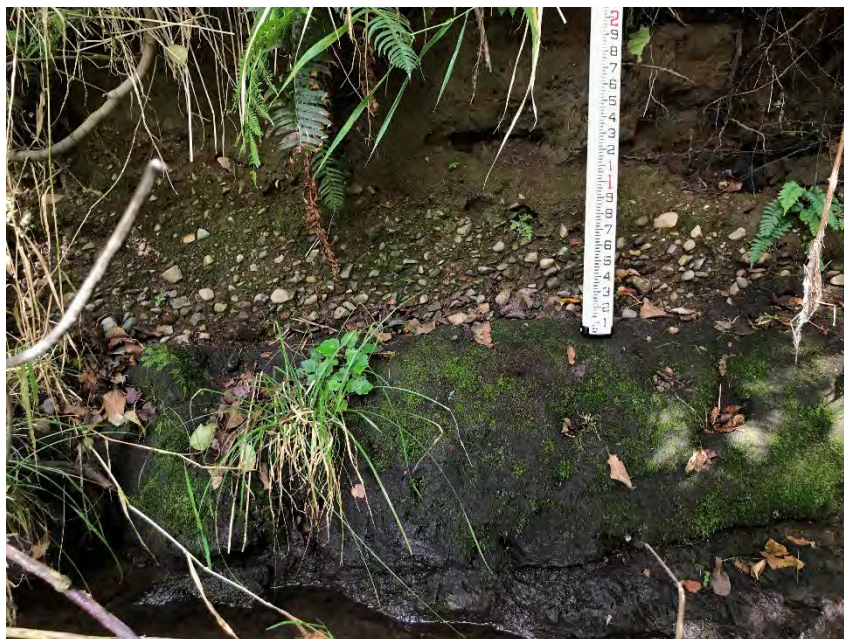
Figure 17: Exposed bank upstream of the stream crossing, showing mudstone bedrock at the base overlain with alluvium and forest soil (Station 28+20)

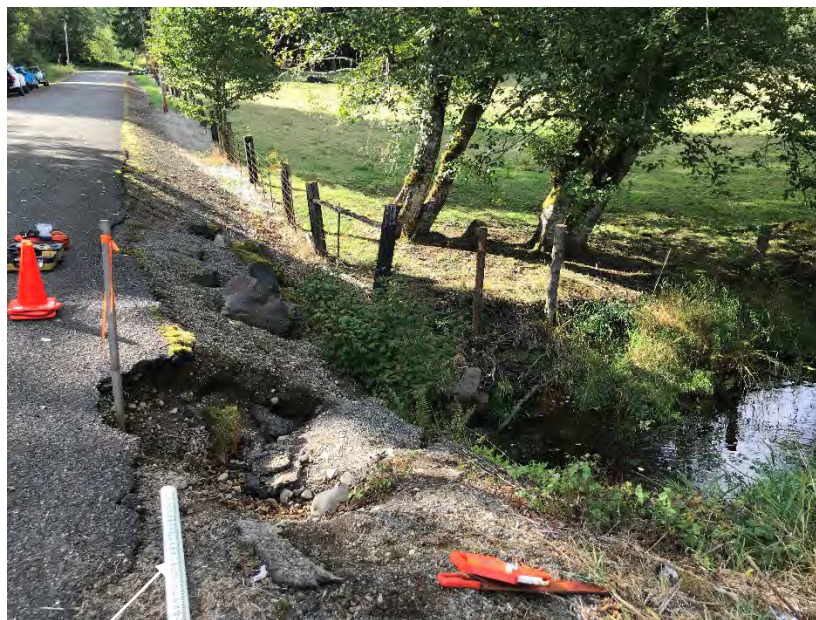
Figure 18 View of the eroding roadway crossing above the culvert outlet (Station 25+50, white arrow indicates flow direction)

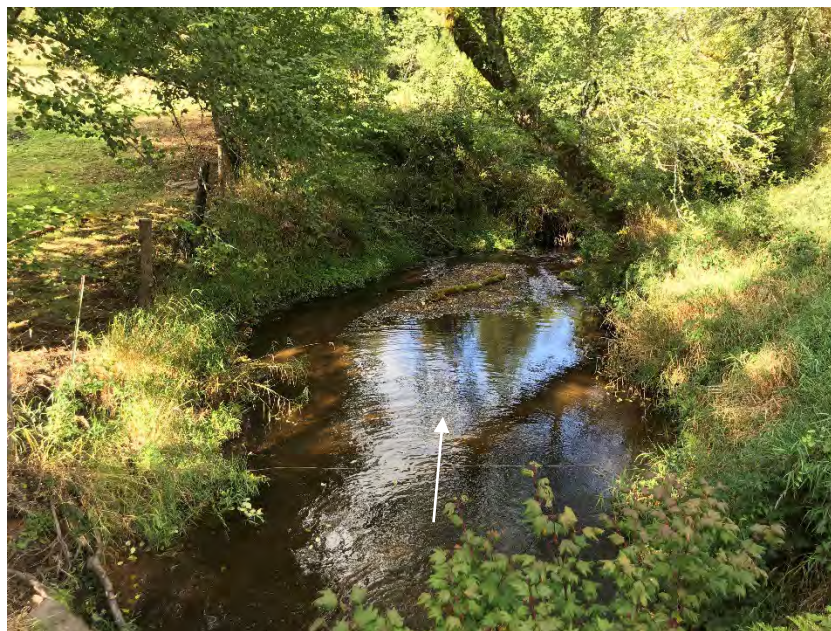
Figure 19: Channel conditions immediately downstream of the culvert outlet as seen from the roadway, with the deep scour pool transitioning into a transverse bar near at the channel bend (Station 25+50, white arrow indicates flow direction)

A riffle-glide and plane-bed at constant 0.7 to 1.5% slope through the crossing is consistent with reach morphology and compatible with observed streambed material size. The scour hole at the existing culvert outlet eroded because of an over-steepened 4% culvert slope, which is inconsistent with both reach-scale morphology and streambed size. The proposed channel will begin downstream of the scour hole and be graded in at 1.2% to fill the scour hole and tie into existing grade upstream.

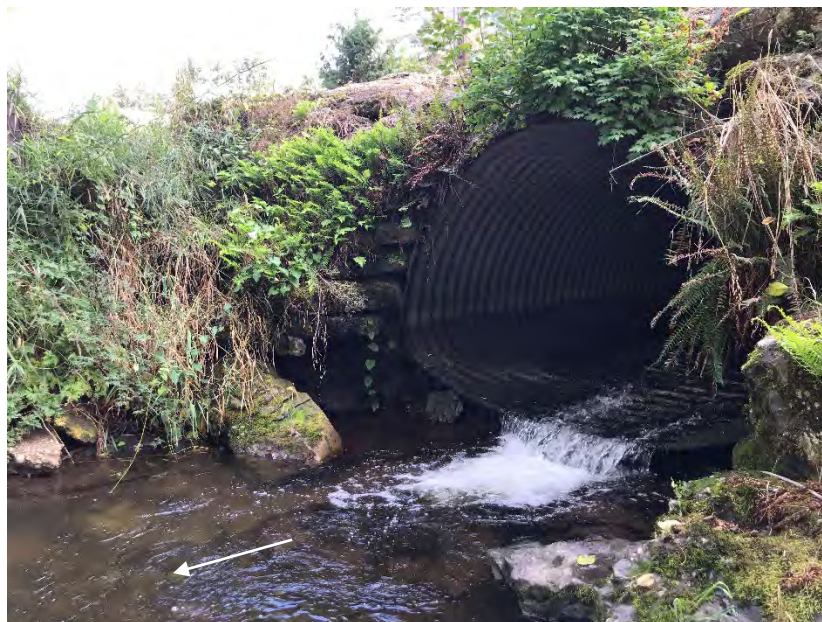
Figure 20 Existing conditions at the culvert outlet, showing a water surface drop and exposed bedrock in the nearby banks and below the culvert itself (Station 26+00, white arrow indicates flow direction)

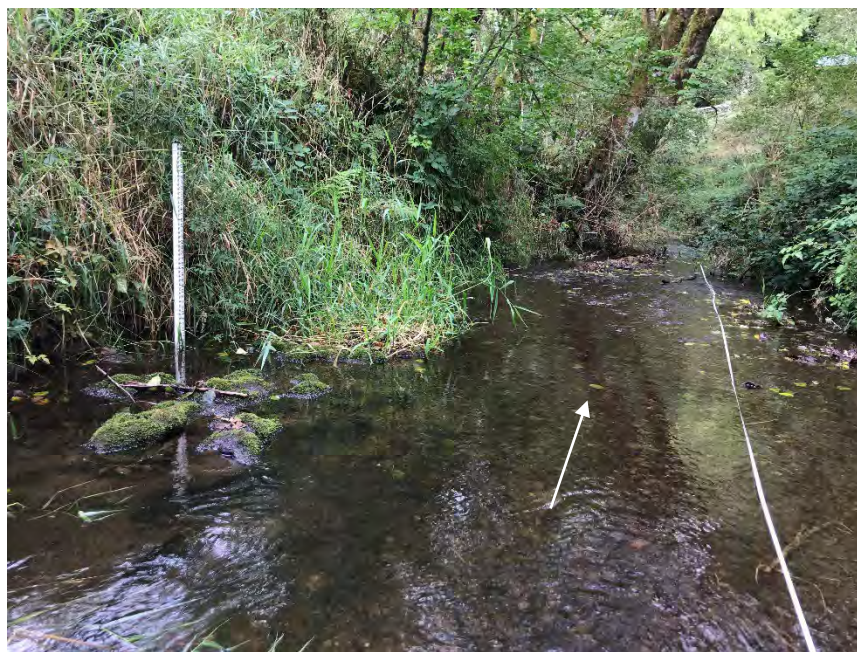
Figure 21 Channel conditions at the transition from the culvert outfall area to the confined reach just downstream of a sharp channel bend (Station 26+70, white arrow indicates flow direction)
